Manhole Inspection Summary

Manhole # S55O__021MH

Location Address: **3301 o donnell st**

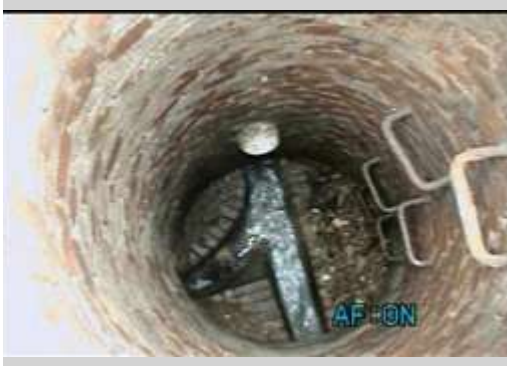
Defect 3

Count: **7** Missing: **1** ☒ Corroded

steps

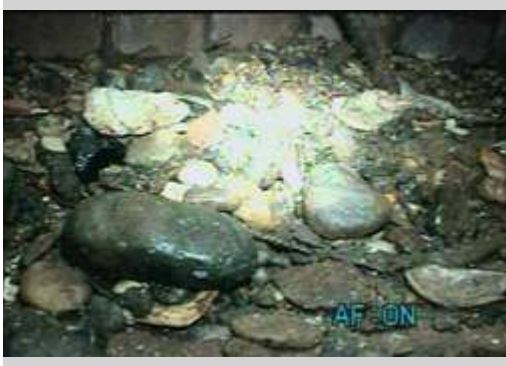
Defect 2

Condition: ☐ Sound ☐ Cracked ☐ Root Intrusion ☐ Deteriorated ☐ Leaks ☒ Debris

bench debris

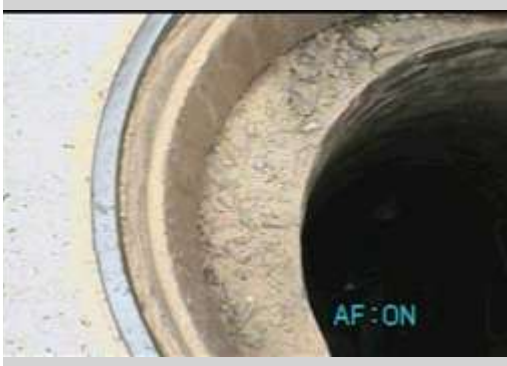
Defect 1

Offset: **7** (in.)

Frame offset

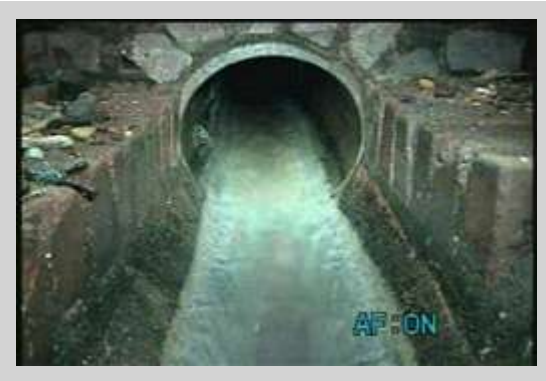
8 in. Circular Gravity Sewer
Pipe Out @ 12 O'Clock

Pipe Height: **0** (in.) Direct
Pipe Material: **Clay** ☐ Pipe Lined
Invert Depth: **7.79** (ft.) Flow Characteristics: **Fast**
Deposits: ☒ None ☐ Mud ☐ Sludge ☐ Debris ☐ Grease
Silt Depth: **0** (in.) Deposits Extent:
Infiltration: **None** Pipe Seal Cond: **Unknown**

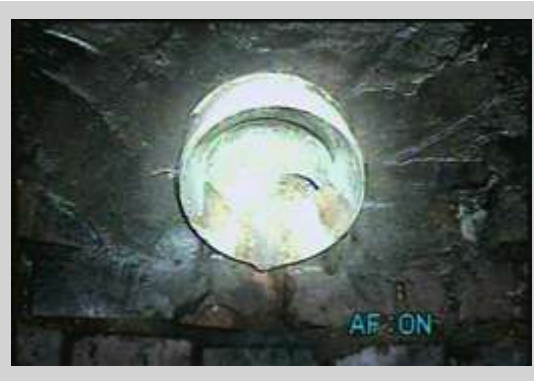
12 O'Clock Outflow
Drop Out @ 12 O'Clock

Drop: **Outside Direct**
Angled: Reading: **0.00** (ft.)
Inv Depth: **12.93** (ft.)
Drop Condition: **Open**

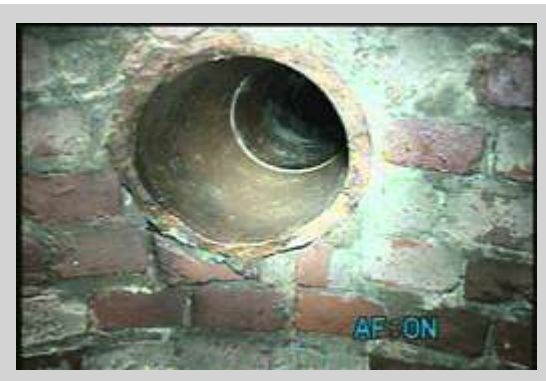
8 in. Circular Gravity Sewer
Pipe In @ 6 O'Clock

Pipe Height: **0** (in.) Direct
Pipe Material: **Clay** ☐ Pipe Lined
Invert Depth: **12.31** (ft.) Flow Characteristics: **Fast**
Deposits: ☒ None ☐ Mud ☐ Sludge ☐ Debris ☐ Grease
Silt Depth: **0** (in.) Deposits Extent:
Infiltration: **None** Pipe Seal Cond: **Unknown**

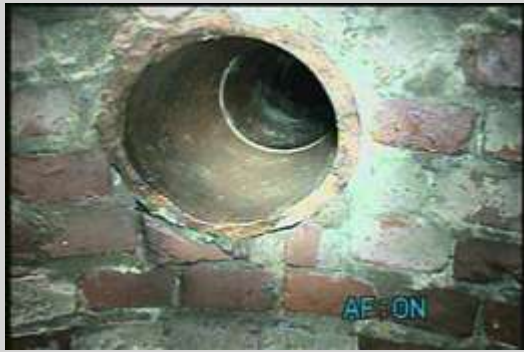
Pipe In @ 9 O'Clock

Pipe Height: **0** (in.) Direct

Pipe Material: **Clay** ☐ Pipe Lined

Invert Depth: **7.68** (ft.) Flow Characteristics: **Fast**

Infiltration: **None** Pipe Seal Cond: **Unknown**

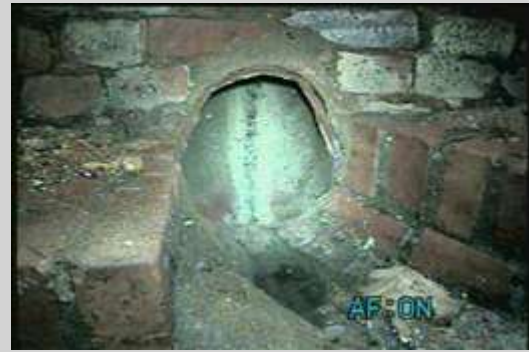
Drop In @ 9 O'Clock

Drop: **Outside** **Direct**

Inv Depth: **9.54** (ft.)

Drop Condition: **Open**

Connects To: **Dead End**
